# Manhole Inspection Summary

Manhole # S13KK1001MH

**Location** Address: **4523 PALL MALL RD**

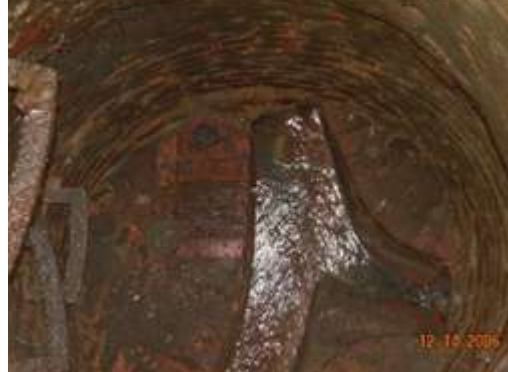
Top View

Corbel and Barrel infiltration. Evidence of surcharge - Bench debris.

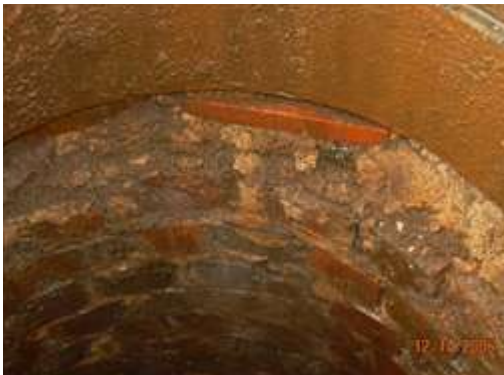
Defect

Frame leaks. Adjustment deterioration and infiltration.

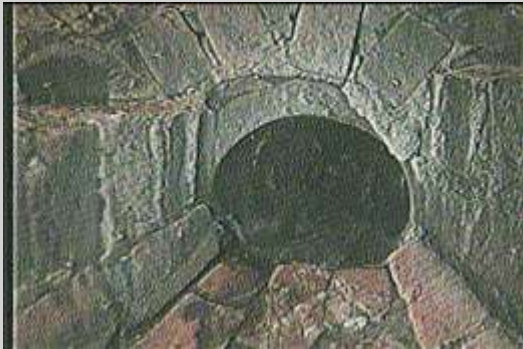
### 8 in. Circular Gravity Sewer Pipe Out @ 12 O'Clock

Infiltration: **Evidence** Pipe Seal Cond: **Cracked**

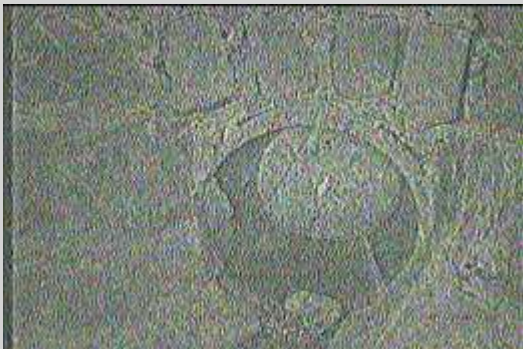
### 8 in. Circular Gravity Sewer Pipe In @ 4 O'Clock

Plugged.

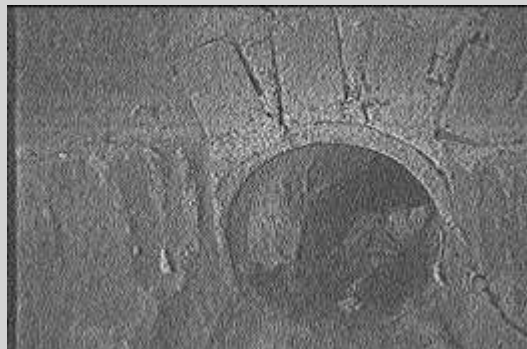
Pipe In @ 7 O'Clock

Comments **The I7 pipe picture shows Channel deterioration.**

Channel deterioration.
